# Manhole Inspection Summary

Manhole # S21K\_\_016MH

Insp Date: **9/25/07 12:19 PM**

**Location** Address: **228 FULTON AVE**

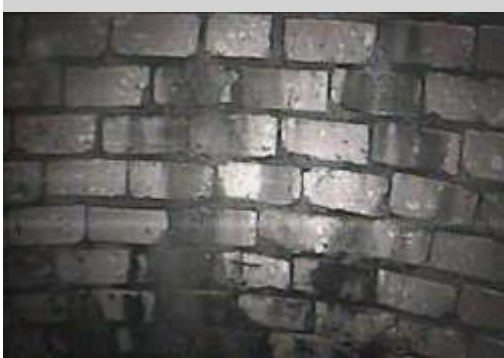
Defect 3

Infiltration: ☐ None ☐ Joint ☐ Cracks ☐ Mortar ☐ Roots ☒ **Wall**

BARREL INFILTRATION

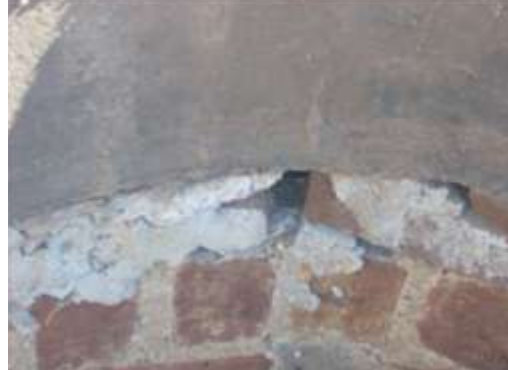
Defect 2

Condition: ☐ Sound ☐ Cracked ☐ Root Intrusion ☒ **Loose Brick** ☐ Deteriorated

LOOSE CHIMNEY BRICKS

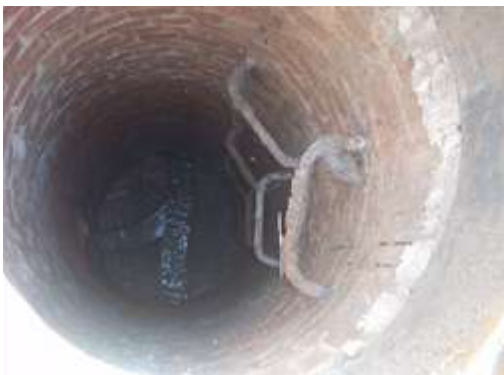
Defect 1

Count: **8** Missing: **0** ☒ **Corroded**

CORRODED STEPS

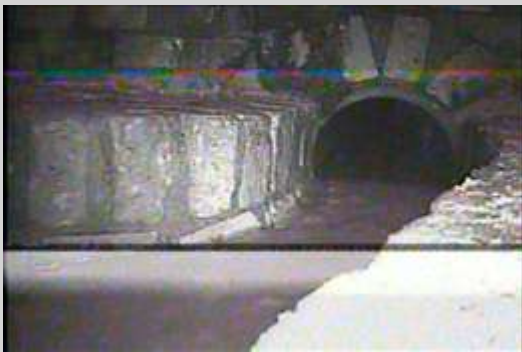
12 O'Clock Outflow

Pipe Height: **8.4** (in.) Rod and Bar (Angled)  
Pipe Material: **Clay** ☐ Pipe Lined  
Invert Depth: **15.13** (ft.) Flow Characteristics: **Slow**  
Deposits: ☒ None ☐ Mud ☐ Sludge ☐ Debris ☐ Grease  
Silt Depth: (in.) Deposits Extent:  
Infiltration: **None** Pipe Seal Cond: **Sound**

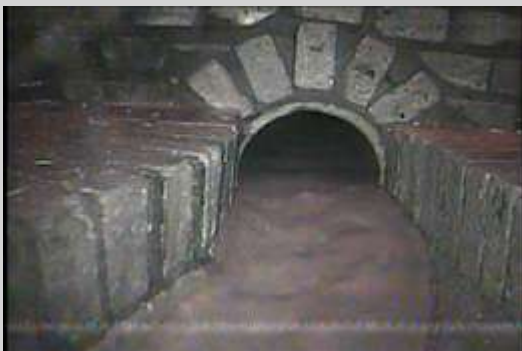
6 O'Clock Inflow

Pipe Height: **8.4** (in.) Rod and Bar (Angled)  
Pipe Material: **Clay** ☐ Pipe Lined  
Invert Depth: **15.07** (ft.) Flow Characteristics: **Slow**  
Deposits: ☒ None ☐ Mud ☐ Sludge ☐ Debris ☐ Grease  
Silt Depth: (in.) Deposits Extent:  
Infiltration: **None** Pipe Seal Cond: **Sound**

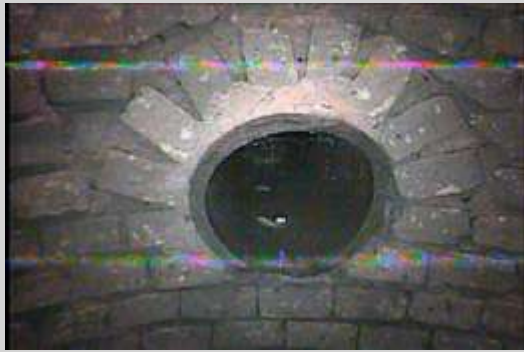
9 O'Clock Inflow

Infiltration: **None** Pipe Seal Cond: **Sound**

Drop: **Outside** Rod and Bar

Drop Condition: **Open**

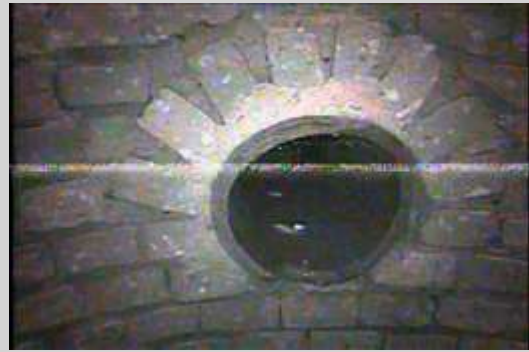
BARREL INFILTRATION
